# **Debris/Ice/TPS Assessment and Integrated Photographic Analysis of Shuttle mission STS-104**

Armando Oliu  
Process Engineering/Mechanical System Division/ET-SRB Branch,  
Kennedy Space Center, Florida

**July 12, 2001**

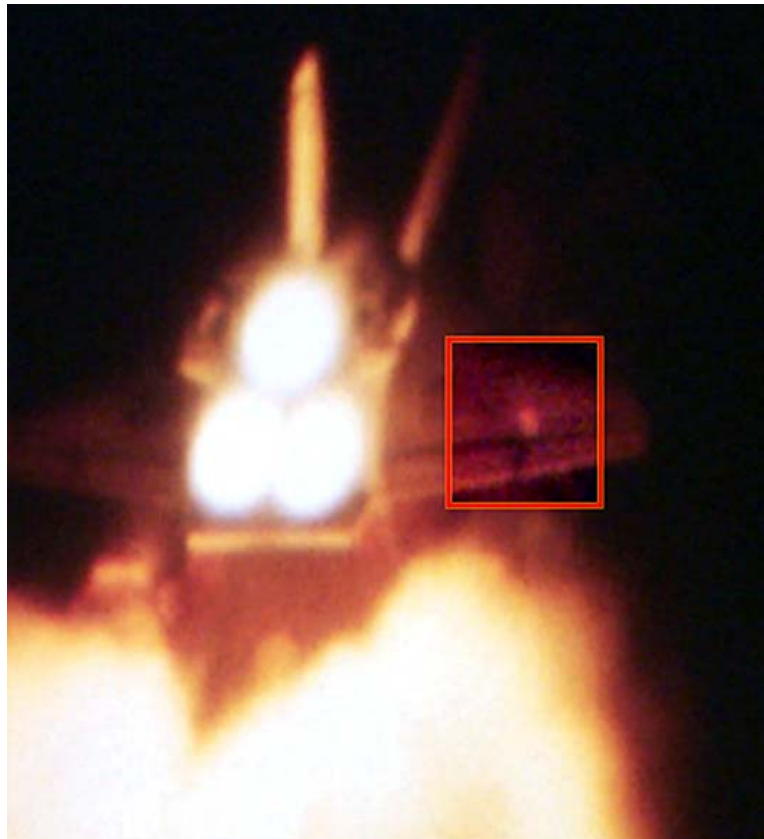
Figure 2.2.2(B) Debris Seen Above Right Wing. (Camera E207)

Several pieces of debris were seen over the port and starboard wings and falling aft of the Orbiter between 2 to 5 seconds prior to SRB separation (Camera E207):

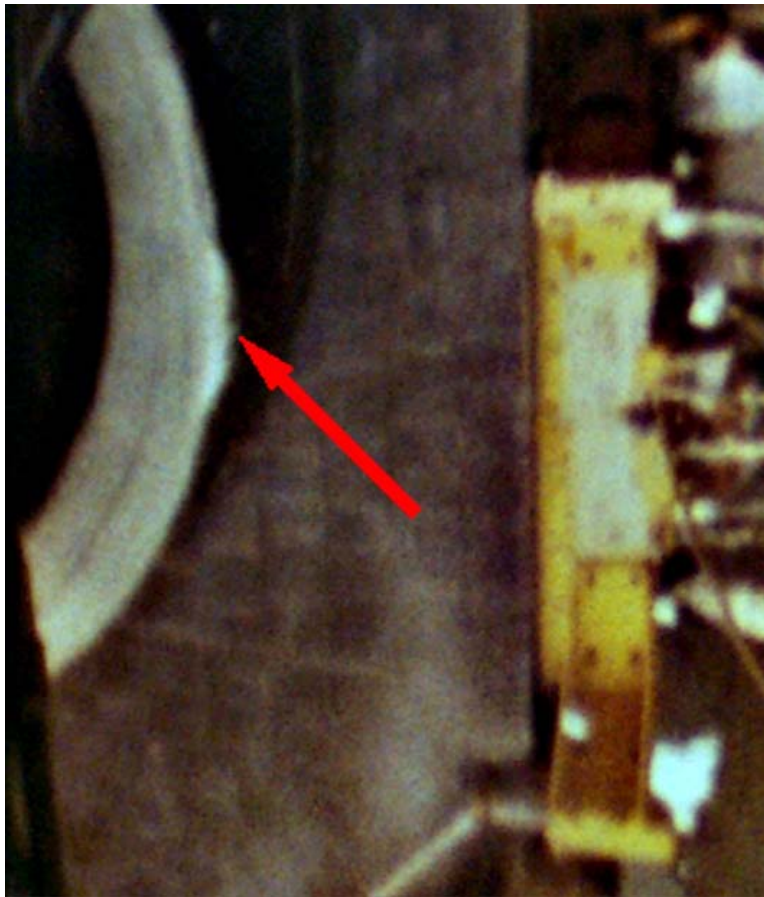
Figure 2.2.3(A) Frayed Thermal Blanket on SSME #2 (Camera E18)

The outboard edge of the SSME #2 dome mounted heat shield (DMHS) thermal blanket was seen to fray during SSME ignition (09:03:55.550 UTC). No significant change to the damage of this thermal blanket was seen on the imagery acquired during the post-landing inspections compared to the pre-liftoff views. (Camera E18)

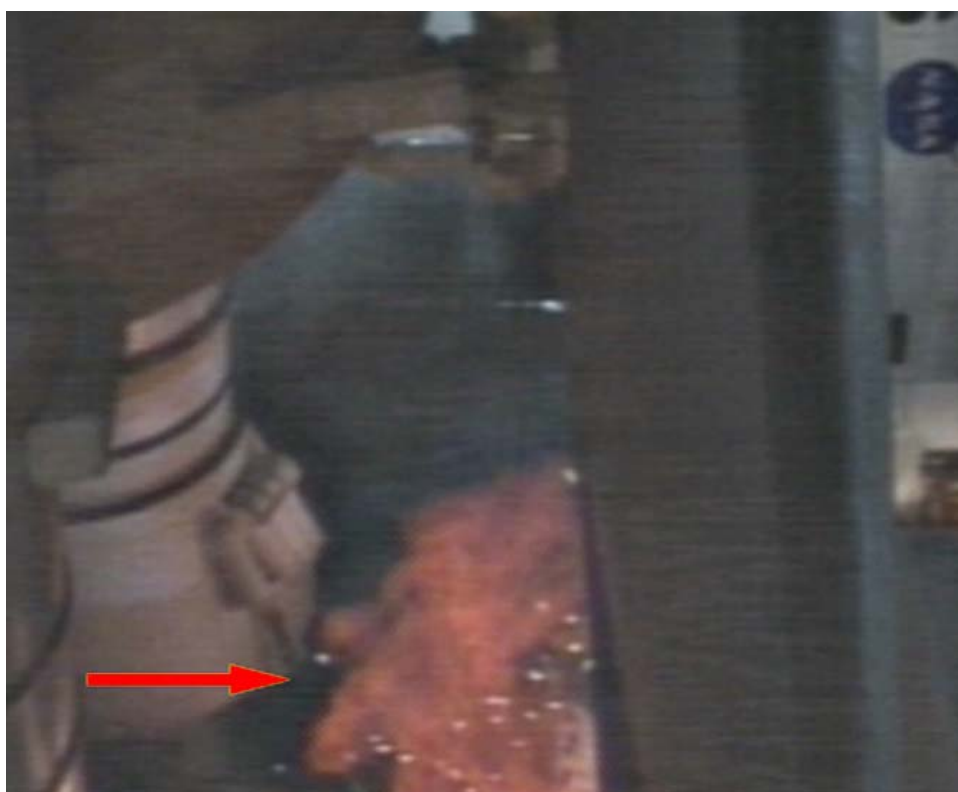
Figure 2.2.3(B) Orange Vapor Seen During Ignition (Camera OTV163)

Orange vapor (possibly free burning hydrogen) was seen forward of the SSME rims during SSME ignition. Orange vapor was also seen along the  $-Z$  side of the body flap, near the trailing edge of the vertical stabilizer, and moving from beneath SSME #3 toward the LO2 TSM during SSME ignition. Orange vapor forward of the aft end of the Orbiter has been seen on previous mission films and videos. (Cameras OTV163, OTV171, E2, E4, E15, E17, E18, E19, E20, E35, E52, E76)

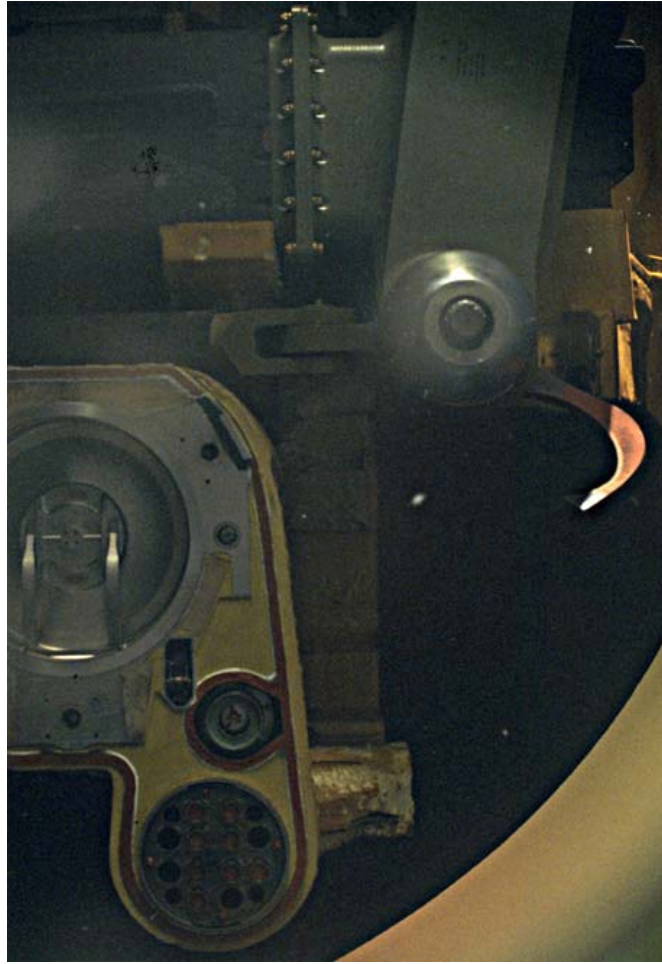
Figure 2.3.2 (A) 35mm Umbilical Well Camera View of ET Bolt (frame 5)

One special interest observation was noted on the 35 mm umbilical well camera film: The separation bolt between the ET and the aft end of the Orbiter (EO-3 fitting near the liquid oxygen umbilical) was observed to be protruding (not fully retracted) and probably free floating. The EO-3 bolt appeared to be similar to the protruded EO-3 bolts seen on STS-106, STS-102, and STS-100. (A Shuttle Program investigation of the STS-106 bolt extension was previously conducted in October, 2000). An animated movie (gif image using multiple views) confirmed that the bolt was free floating and not rigid. (A rigid bolt is a concern since it could interfere with the proper separation of the ET from the Orbiter.) Also, what appeared to be possible damage to the visible end on the EO-3 bolt was noted. However, engineering personnel at JSC explained that when the booster cartridges fire, the frangible nut splits into two pieces that rebound inside the debris container. The end of the separation bolt quite often is impacted at that time. Also as the bolt pulls out of the container, the frangible nut halves scrape along the side of the bolt. Many of the bolts that had been used in qualification tests showed the same type of markings. Therefore, the scrape marks seen on the end of the STS-104 (ET-109A) EO-3 bolt are not anomalous.

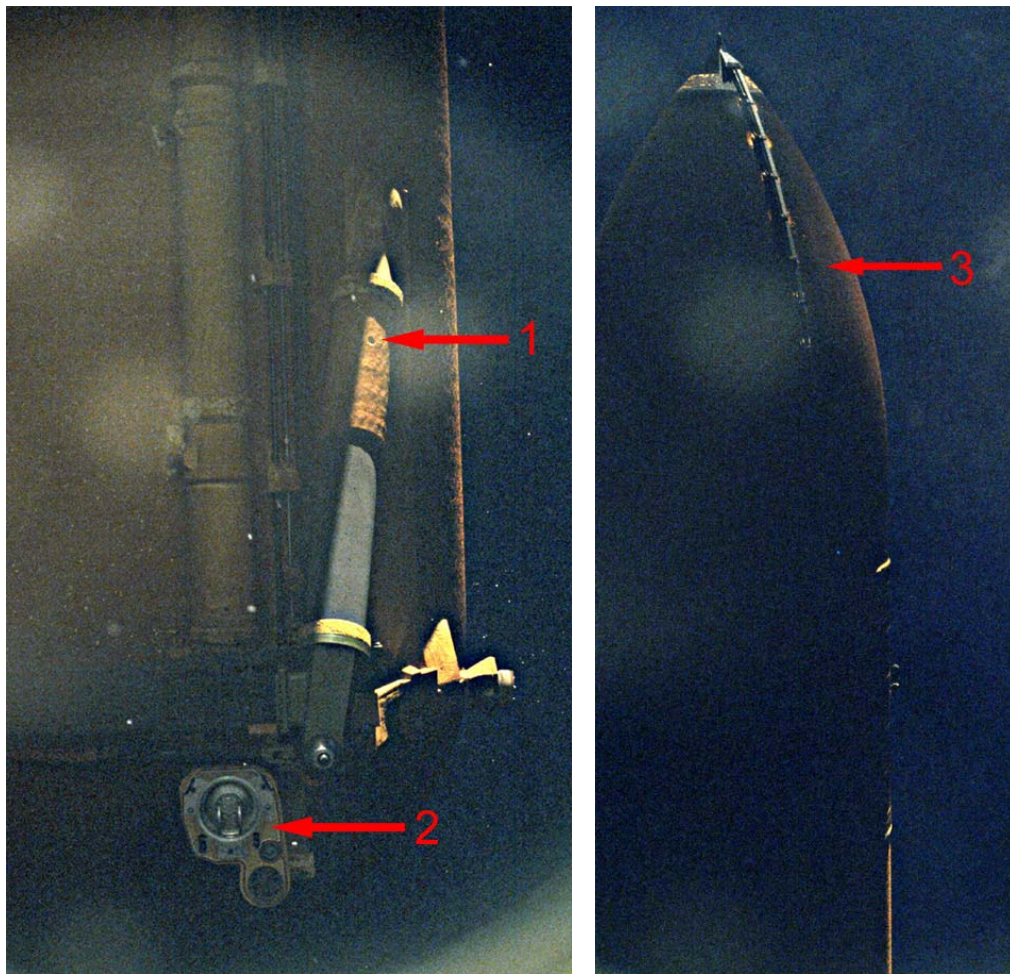
Figure 2.3.2 (B) 35mm Umbilical Well Camera Views of the Aft and Forward ET (frames 15, 53)

A circular-shaped divot with a dark center (possibly due to shadow), approximately two inches in diameter, was visible near the forward end of the +Y thrust strut. See figure 2.3.2 (B), annotation 1. Minor TPS chipping and very small divots (typical of previous missions) were seen on the aft LO2 feedline flanges and on the aft bracket over the press lines. Small, shallow areas of TPS erosion and divoting were visible on the aft flange of the +Y ET/Orbiter thrust strut and on the aft bellows of the LO2 feedline. Typical ablation and divoting of the TPS on the vertical section of the +Y electric cable tray adjacent to the LO2 umbilical were detected.

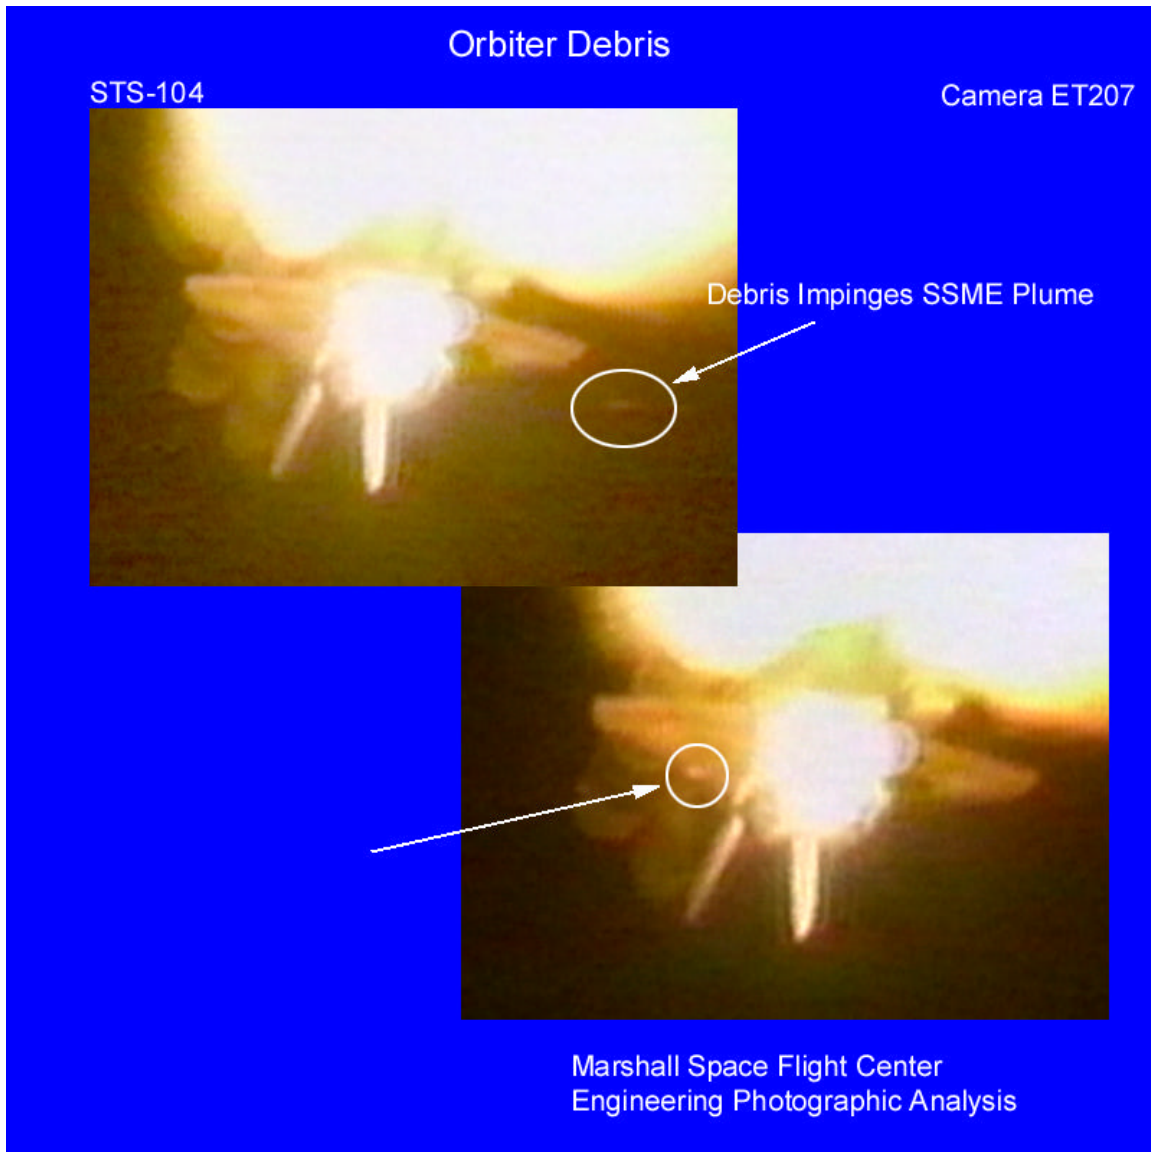
**Figure 1. Orbiter Debris Near SRB Separation**

This debris did not appear to be slag ejected from the SRB plumes.

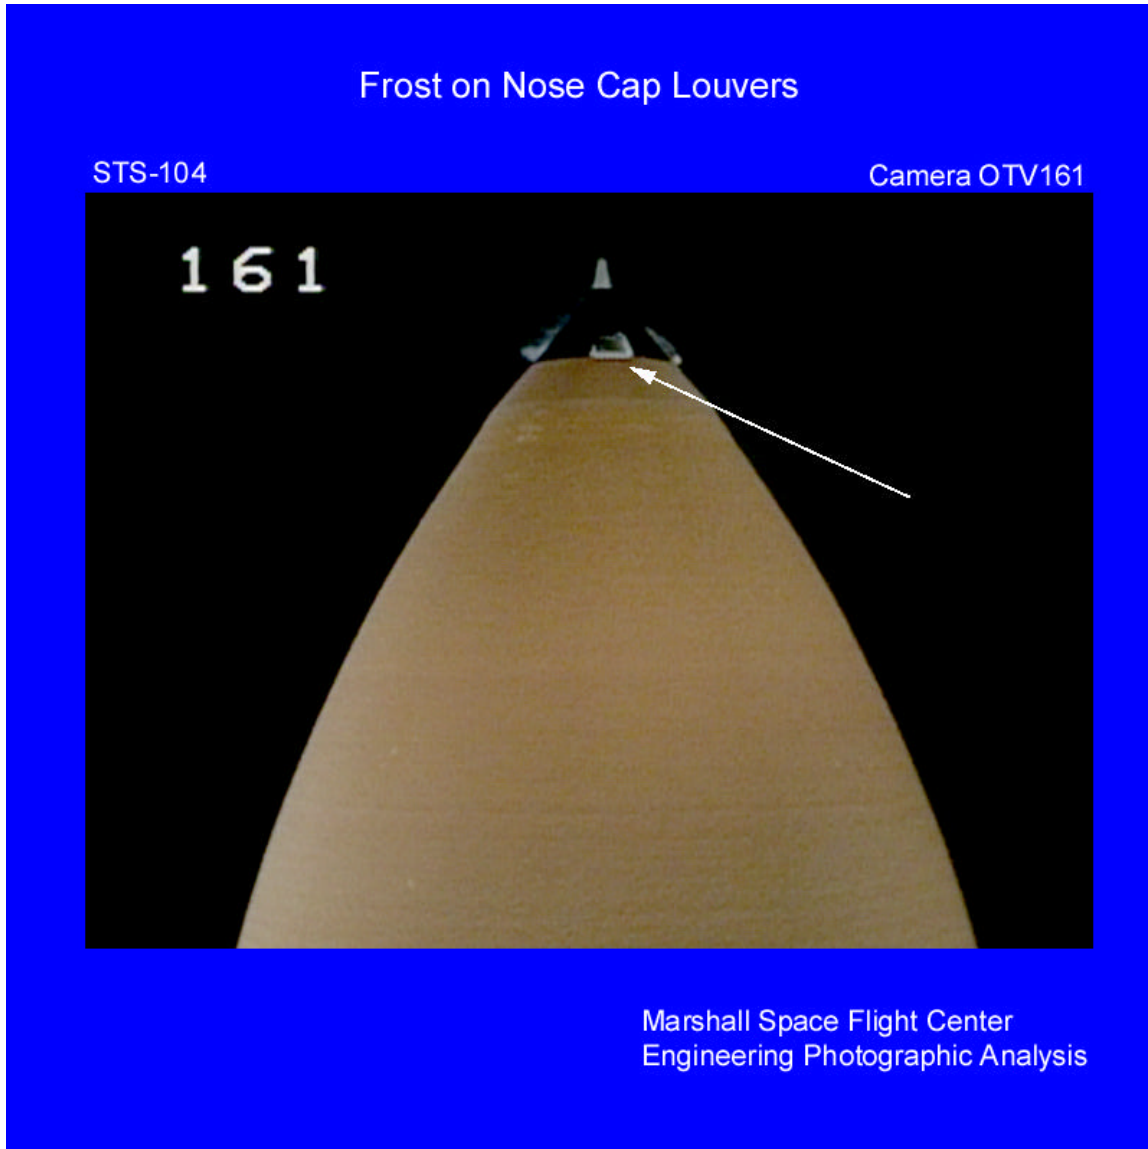
**Figure 2. Frost on ET Nose Cap Louvers**

Edges of the louvers on the External Tank appear to be coated with frost prior to liftoff.

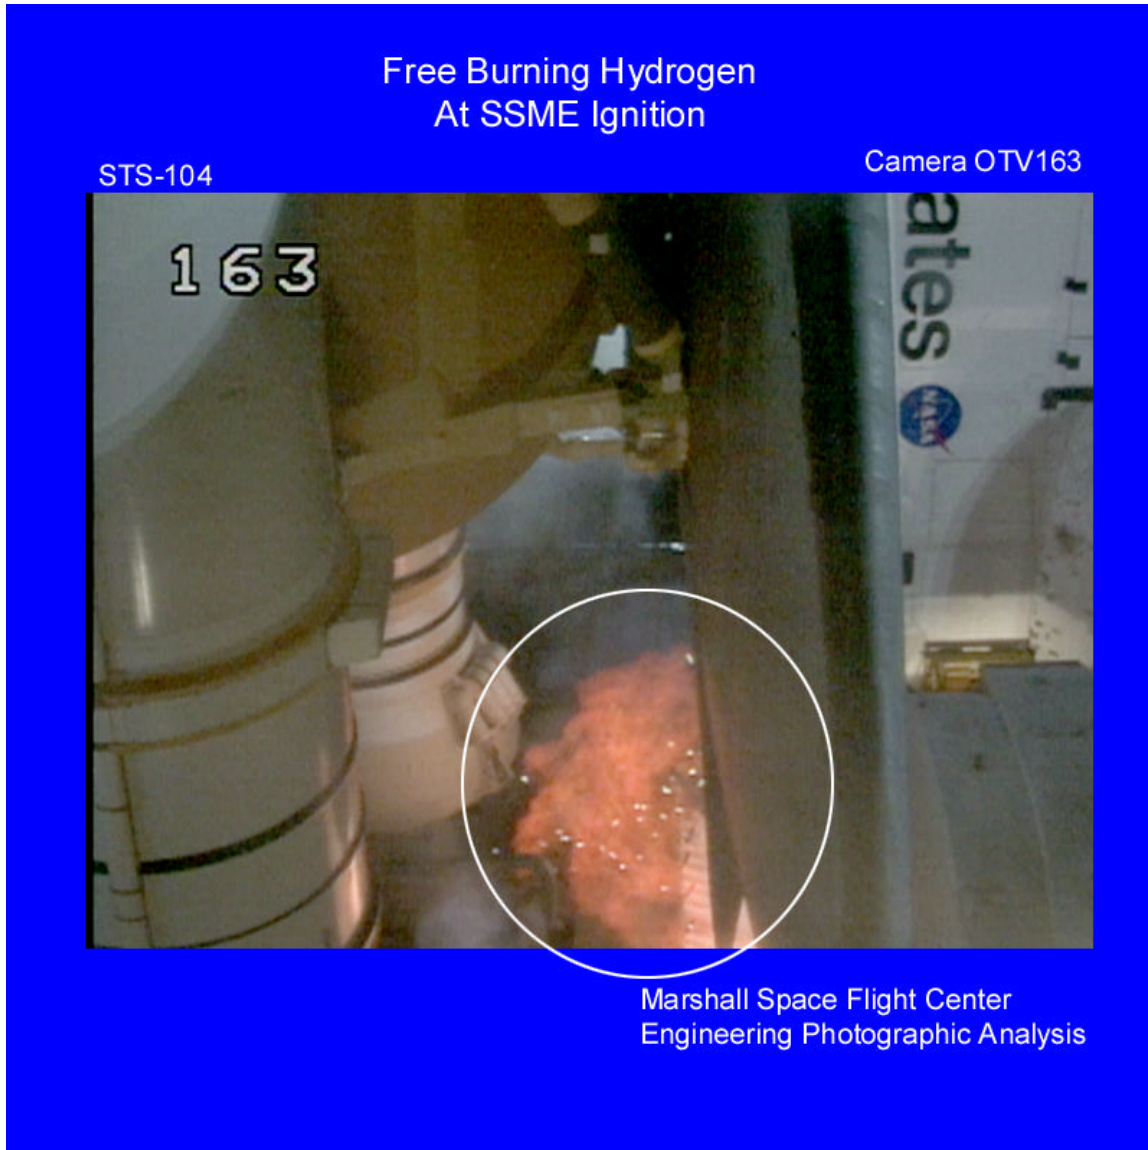
**Figure 3. Free Hydrogen Burning at SSME Ignition**

Free burning hydrogen was observed on the -Z side of the body flap under the ET at SSME startup. This type of event is typical.

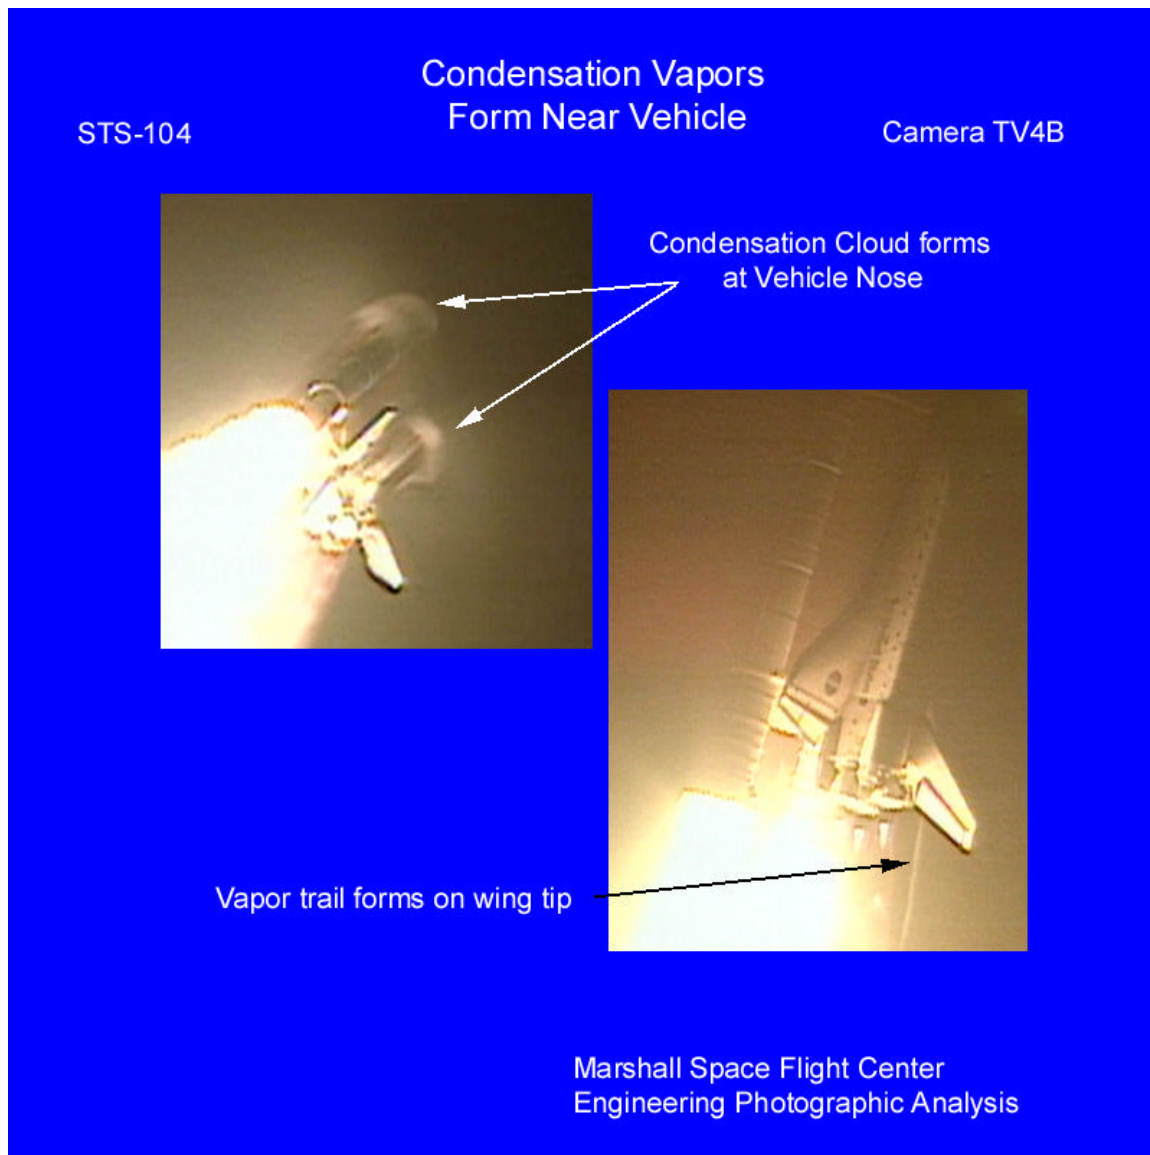
**Figure 4. Condensation Vapors**

Condensation vapors were noted around the forward section of the vehicle and trailing from the orbiter wingtips during ascent. This phenomenon is common in high humidity.

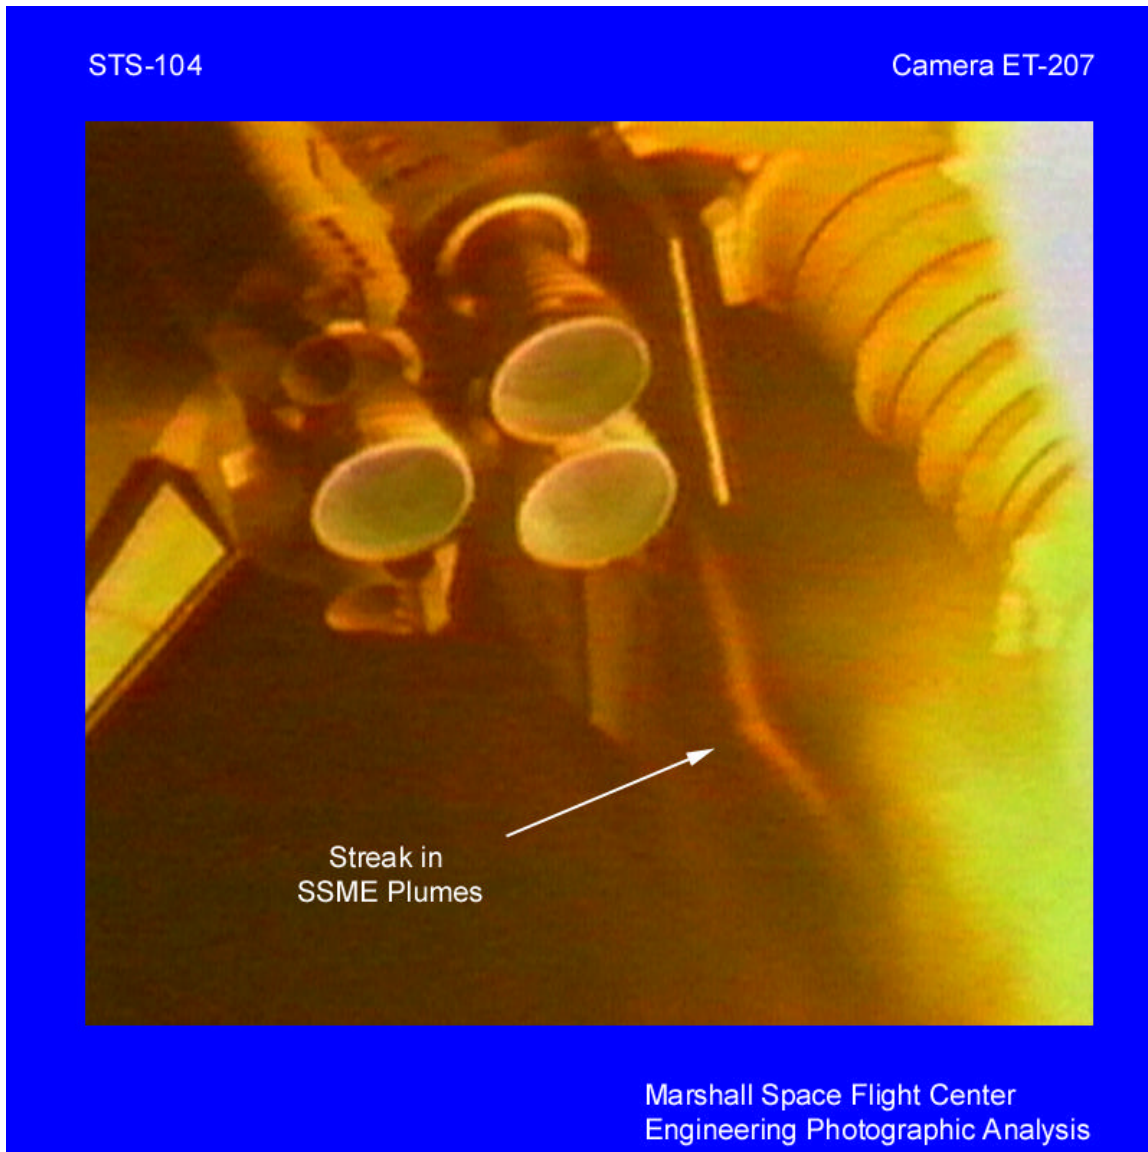
**Figure 5. Streak in SSME Plumes**

Several debris induced streaks in SSME plumes were observed on this mission. The streak shown in Figure 5 is thought to be a debris-induced streak.

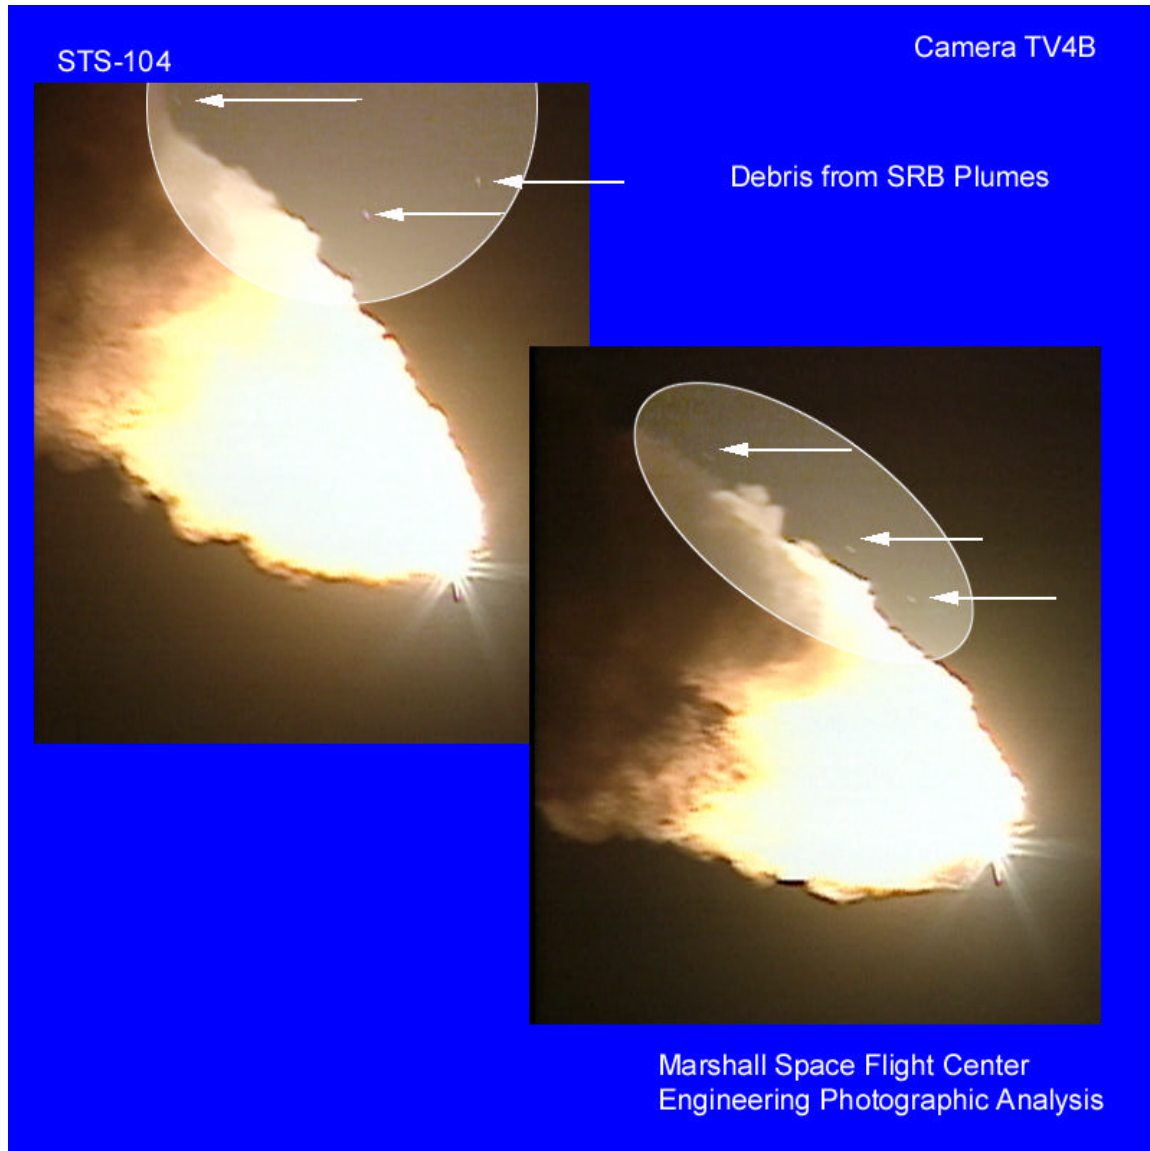
**Figure 6. Debris Ejected from SRB Plumes**

Several pieces of debris were ejected from the SRB plumes during ascent. This debris is thought to be Instafoam from the SRB aft skirt thermal protective surface. Due to lighting conditions during night/early morning flights, this type of debris becomes more visible.

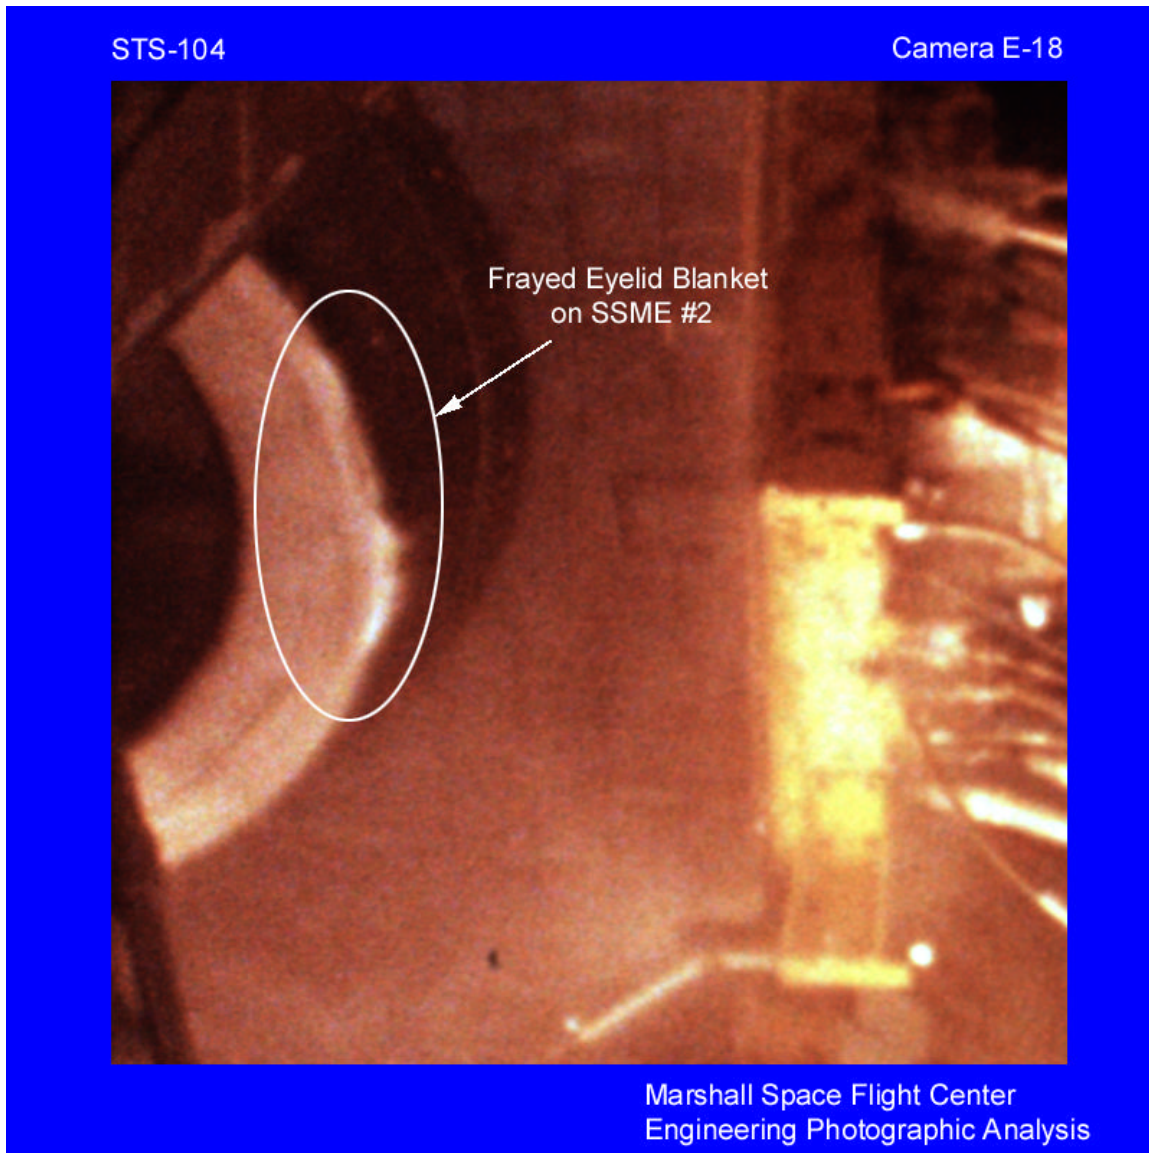
**Figure 7. Frayed SSME#2 Eyelid Blanket**

A portion of SSME#2 Eyelid Blanket appeared to be frayed during SSME startup.

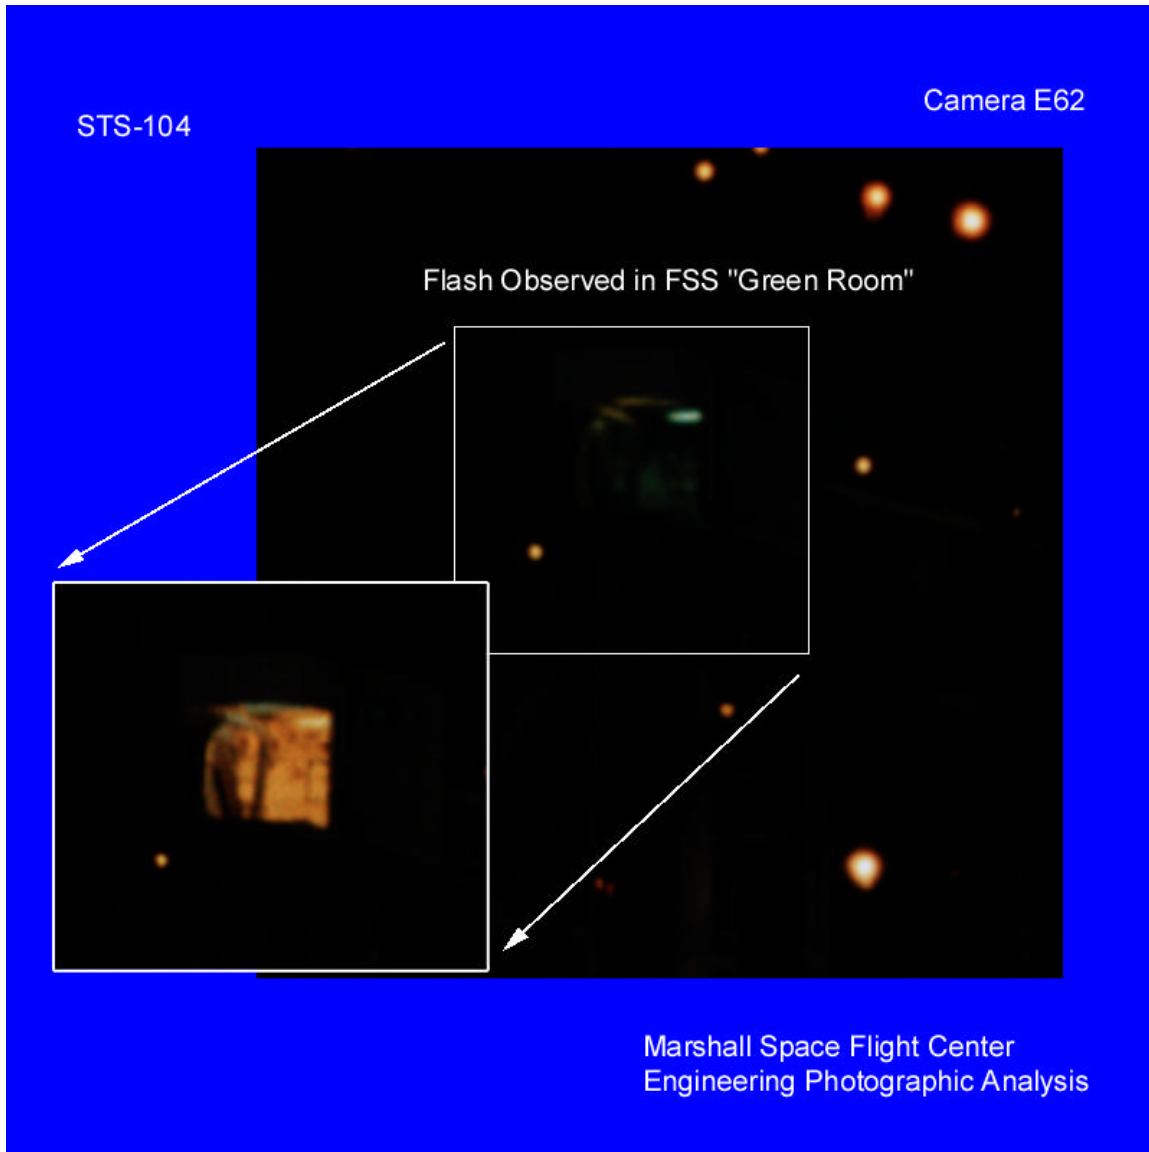
**Figure 8. Flash in Green Room**

A flash was observed in the Green Room, 193:09:03:51:860 UTC, prior to lift-off. In Figure 8, a normal frame exposure of the Green Room in this time frame is contrasted with the single frame in which the flash was detected.

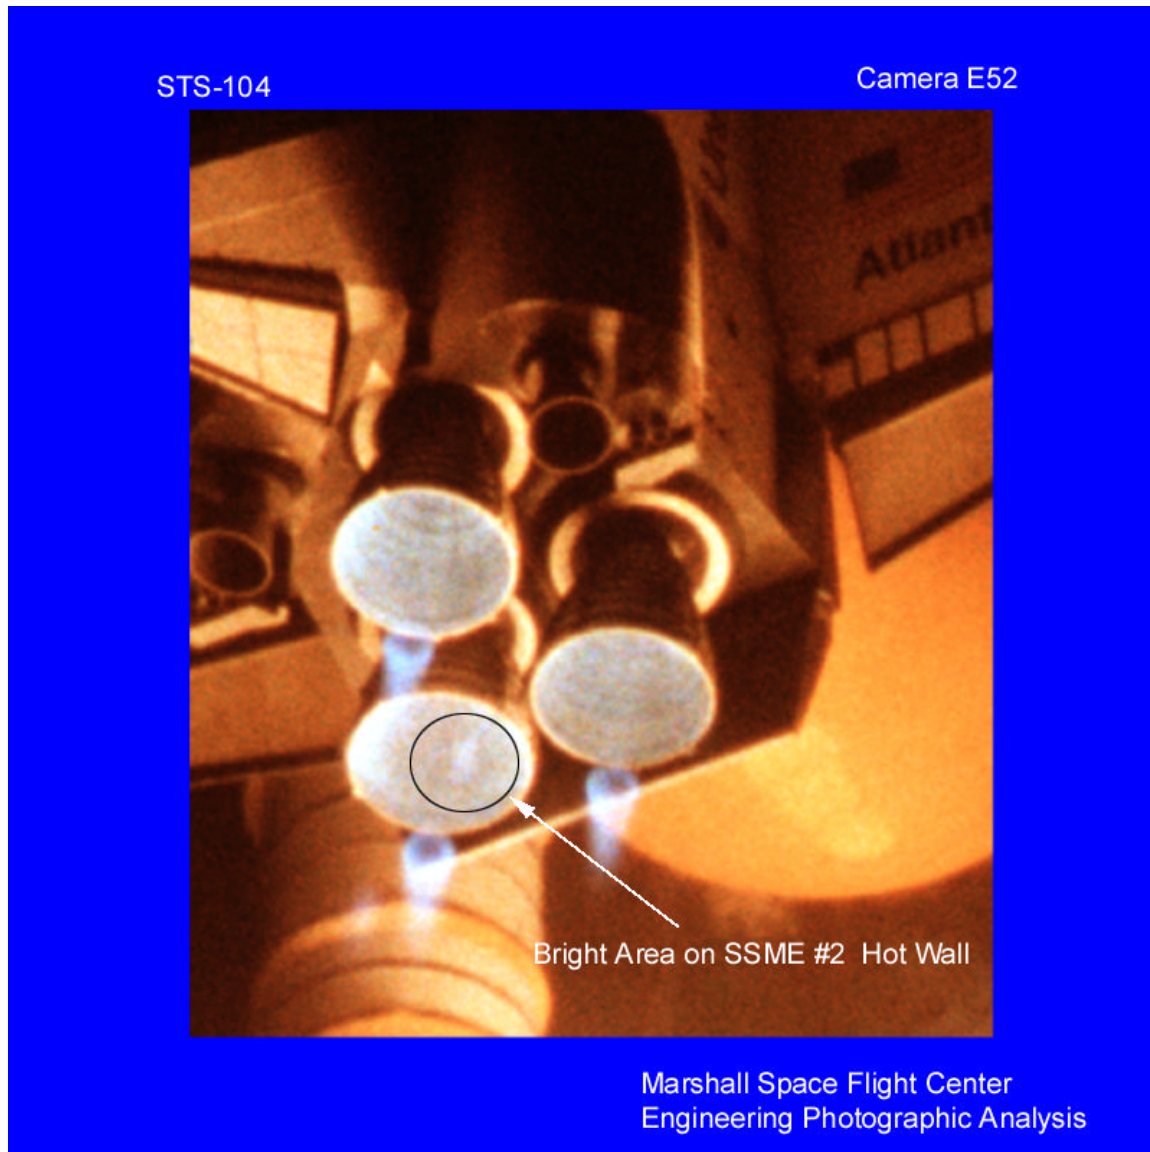
**Figure 9. Bright Spot on SSME #2 Nozzle Hot Wall**

A light colored, bright area was observed on the hot wall of the SSME#2 nozzle. Bright areas have been observed during SSME testing and have been associated with nozzle repairs.

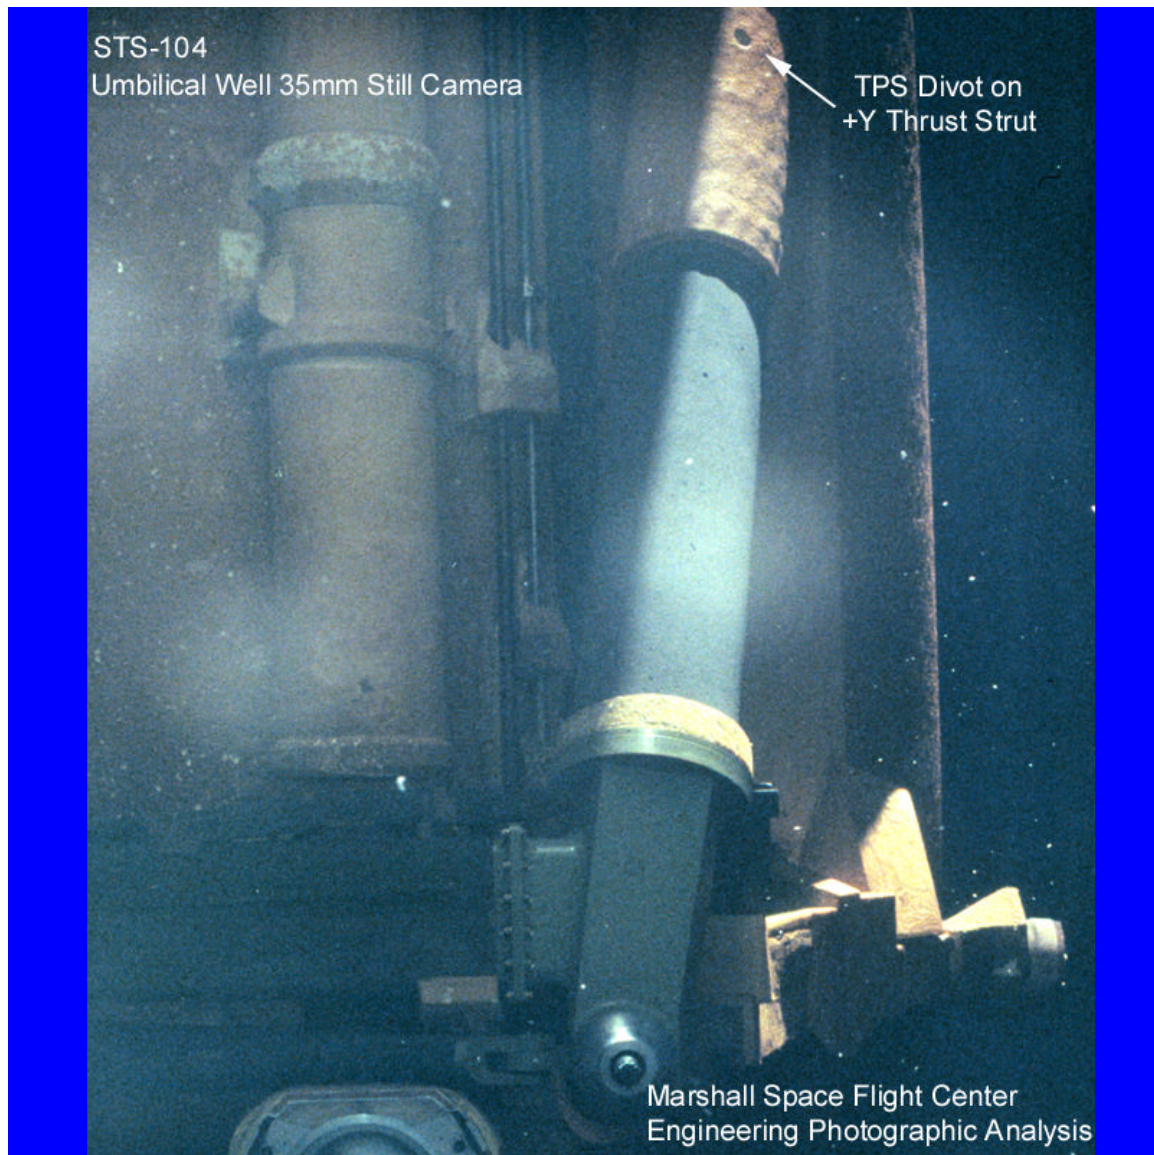
**Figure 10. Divot on ET Aft +Y Thrust Strut**

A notable divot was observed on the ET Aft +Y thrust strut. The divot appeared to be approximately two inches in diameter.

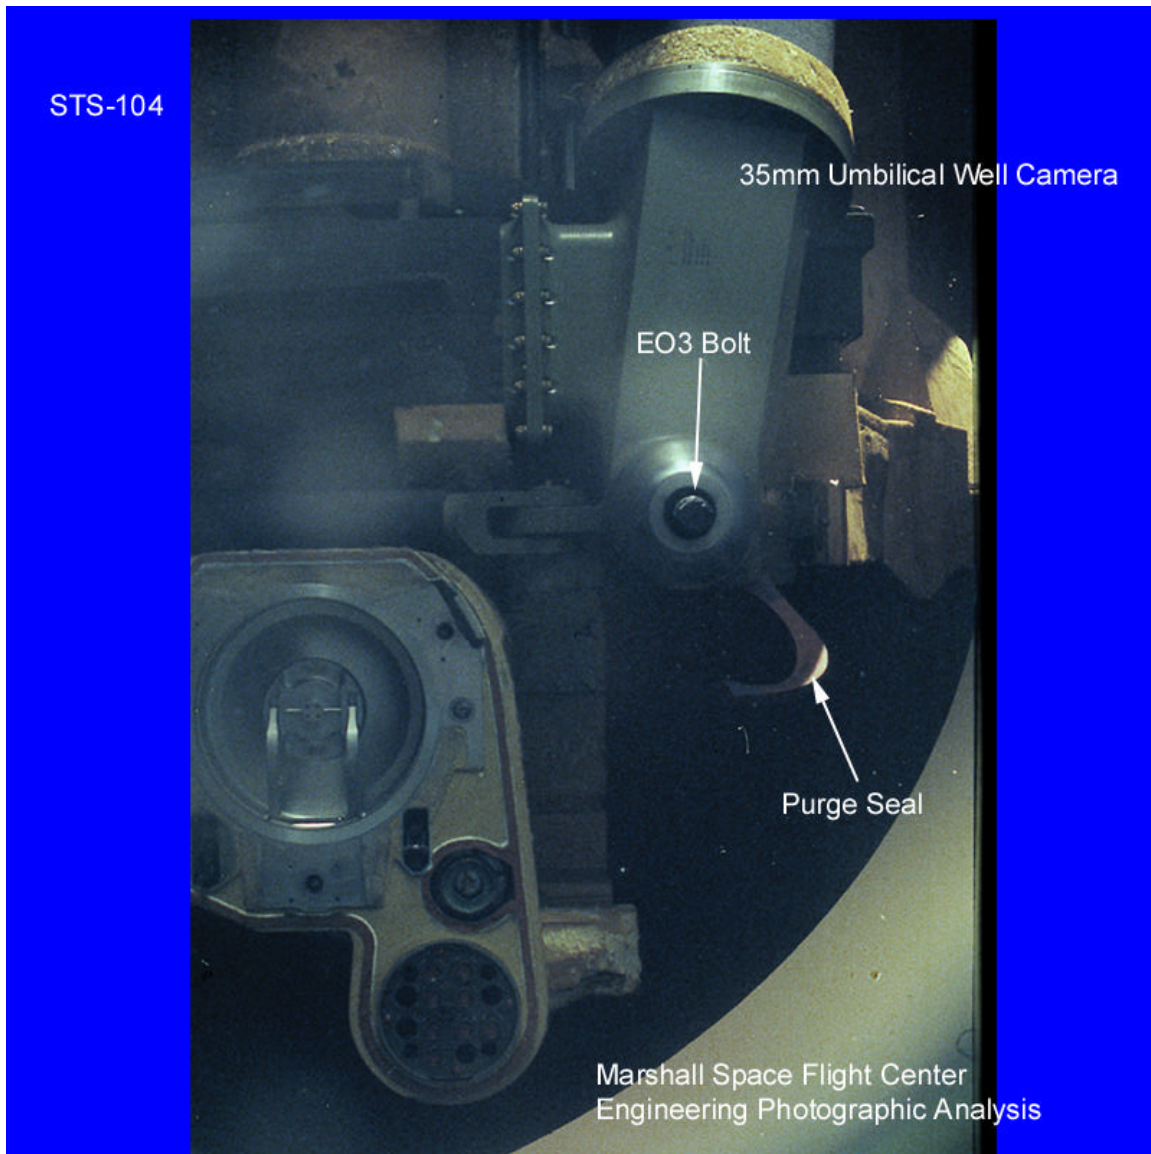
**Figure 11. Protruding EO-3 Separation Bolt**

The protruding EO-3 bolt has also been observed on three recent missions: STS-106, STS-102, and STS100.
